Jungle Trail Shoreline Stabilization Project

Mangrove Mitigation - Indian River County, Florida, USA

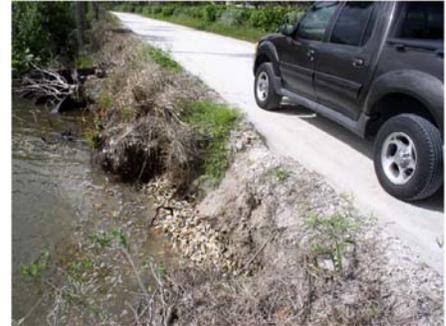
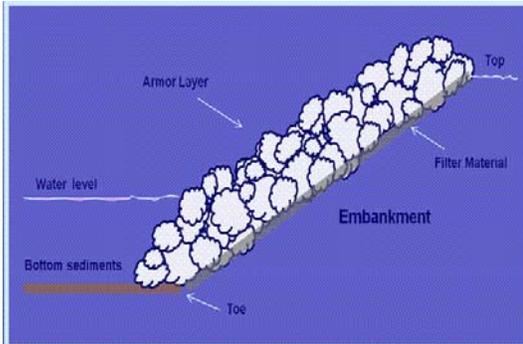
Construction - the project consisted of placing approximately 2,191 tons of coquina boulders along the shoreline and planting native vegetation within the newly constructed roadway shoulder. Mangrove mitigation utilizing REM methodology was implemented subsequent to completion of the revetment construction since conventionally planted mangroves did not survive the first monitoring period. The erosion control project covers approximately 950 feet of shoreline running along the west side of the unpaved Jungle Trail roadway.

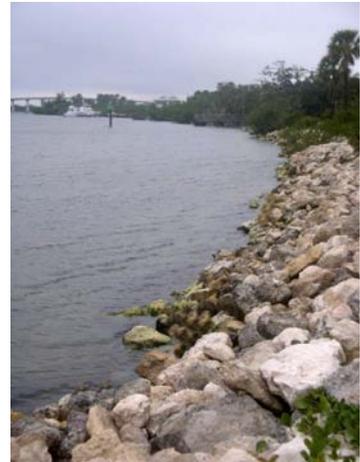
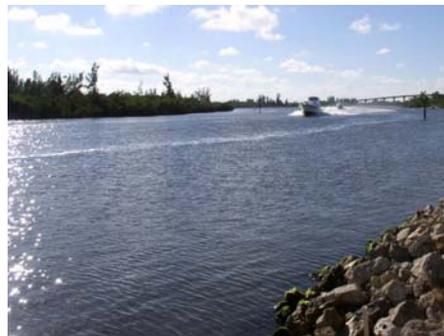
Revetments are commonly constructed on sloping embankments to protect against erosion caused by waves and currents. The revetment may be a rigid cast-in-place concrete structure; but more commonly it is a flexible structure constructed of stone riprap or wire mesh filled with stone (gabions). The typical revetment employs stone riprap as the armor material (see illustration), which resists wave and current-induced hydraulic forces. Major components also include a filter layer under the armor to permit water seepage out of the underlying sediments while retaining fine soil particles making up the embankment. The establishment of a mangrove fringe with REM provides a mechanism to stabilize the toe as-well-as help maintain the long-term structural integrity of the construction.

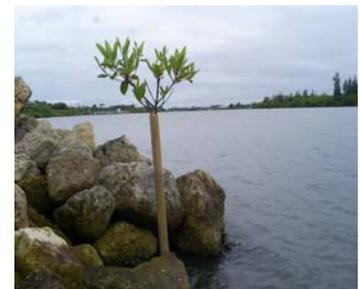
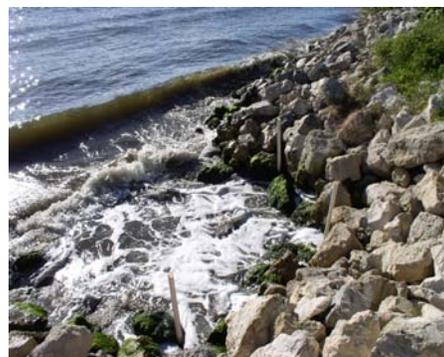
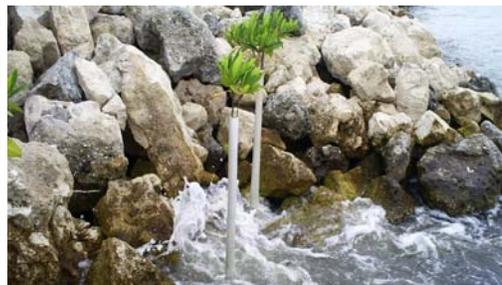
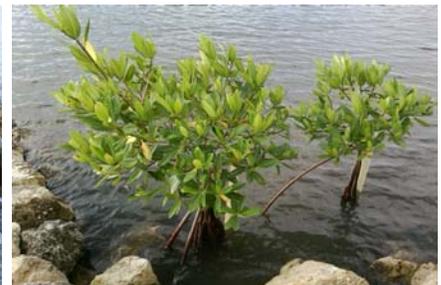
The establishment of reproductively mature mangroves along revetments and bulkhead utilizing Riley Encased Methodology® improves stability of the hardened structure, softens the shoreline to dissipate wave energy and provides additional habitat contributing to the marine ecosystem.
